FORM A - AREA

Town/City: Beverly

Name of Area: Public Works Department Complex

BEVERLY PUBLIC WORKS DEPT. COMPLEX

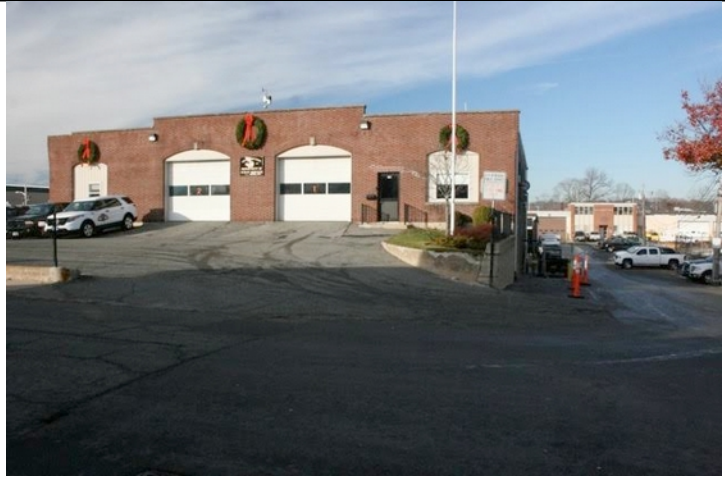
Photo 1. Municipal Garage (foreground) and Water Service Building (background): View west.

At the corner of Park and Roundy streets, is the Municipal Garage (1941-42; Photos 1, 2, and 3) is the most prominent building on the site. It faces Park Street and is set back from the street edge behind a large paved parking area. Measuring 80 feet (north/south) by 70 feet (east/west), this building rises to a flat roof above its one-story east (façade) elevation, with a fully exposed basement at the side and rear elevations. The east (façade) elevation is faced with Flemish-bond brick and surmounted by a stepped parapet. It is distinguished by two vehicle bays in the center flanked by a single large window on each outer bay; each of these openings has a segmental arch and gauged brick lintel with a granite keystone. The side and rear elevations are clad with small granite blocks (somewhat larger in size than paving stones) and feature varied, mostly symmetrical arrays of small and large window openings. The building's windows and pedestrian doors typically exhibit segmentally arched openings with double course lintels; all window openings have been filled in with wood sheathing and fitted with small replacement window sash. Three large vehicle bays on the rear (west) elevation have rectangular openings and a continuous concrete lintel. Visible structural elements include concrete piers in the basement and steel framing at the first floor.

Facing the western terminus of Roundy Street, the linear shape of the Water Service Building (ca. 1965 and following; Photos 1 and 7) is aligned along the western edge of the property. This building consists of a two-story center section (containing offices) and one-story garage wings to the north and south, all with flat roofs. The three-bay east (façade) elevation of the middle segment has a brick veneer center bay with a recessed center entrance, and outer bays containing a band of four vertical windows at each floor, separated by metal spandrel panels. The side walls of this center segment are clad with brick. The long north wing, constructed of concrete block, has three large vehicle bays grouped at its northern end. The southern wing is a tall, one-bay structure known as the Packer Garage; it features a large vehicle bay on its east (façade) elevation and corrugated metal sheathing on its south elevation.

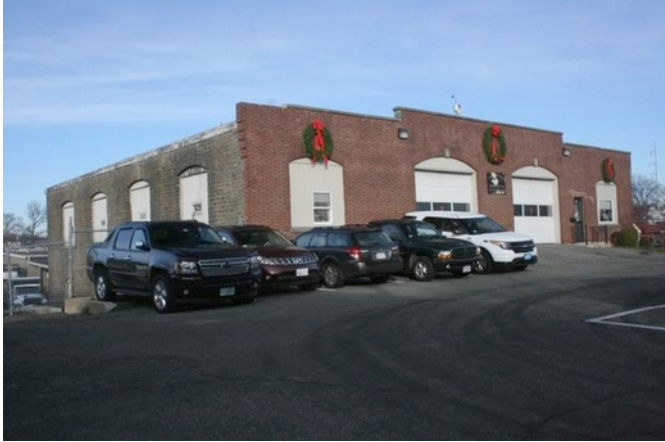
Photo 2: Municipal Garage, south and east (façade) elevations

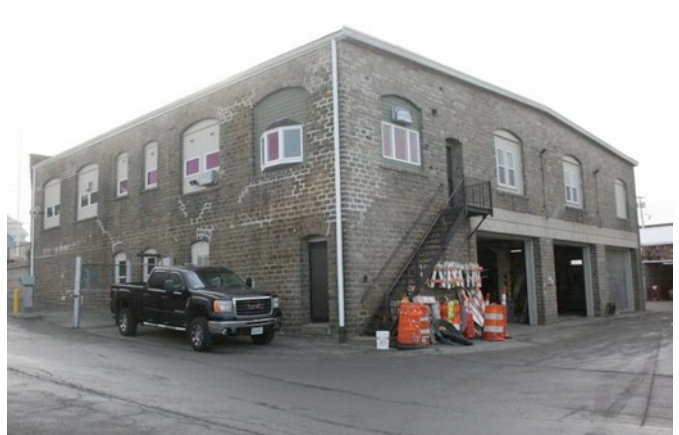
Photo 3: Municipal Garage, north and west elevations

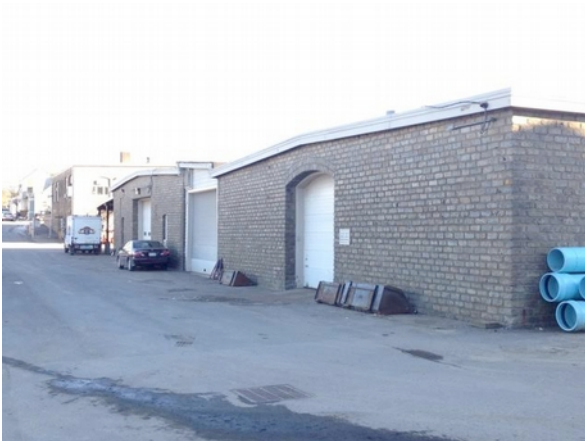
Photo 4. DPW Repair Shop and Garage (L) and DPW Garage (R), north (façade) elevations

Twin stone structures were added in the middle of the property in the 1930s, built at separate times but very similar to each other in design, form, and materials. The DPW Garage (1934) on the west and DPW Repair Shop and Garage (1937) on the east (Photos 4 and 5) are large, one-story volumes built of small granite blocks with segmentally arched openings, like the Municipal Garage, surmounted by shallow front-gable roofs. These two closely-spaced structures appear to have been originally connected at their southern end by a small link of matching masonry construction; the northern end of the intermediate space was later enclosed with a wood frame façade and a low shed roof. The gable-end elevations of the two main blocks each contain a central vehicle entrance, which is rectangular with a concrete lintel on the north façade of the eastern block and segmentally arched in other locations. Segmentally arched window openings appear in both wide and narrow sizes. Building elevations are generally symmetrical, with minimal fenestration; all doors and window sash are modern replacements. Visible structural elements include wood ceiling joists and massive steel I-beams in the DPW Garage on the west. An open, five-bay shed for vehicle storage lines the east side of the DPW Repair Shop and Garage; it features steel posts on concrete bases, wood beams and ceiling joists, and a shed roof.

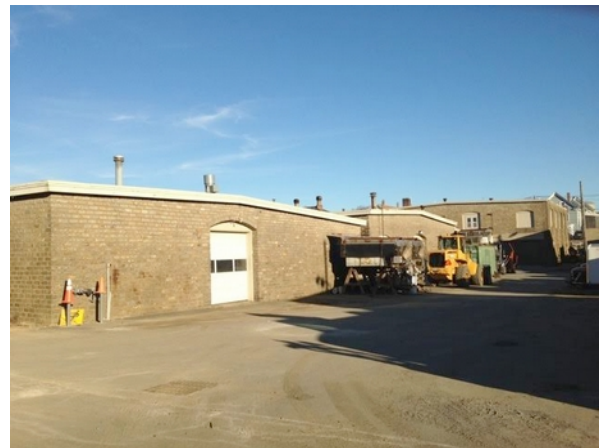
Photo 5. DPW Garage (L), DPW Repair Shop and Garage (C), south elevations, and Municipal Garage (far R)

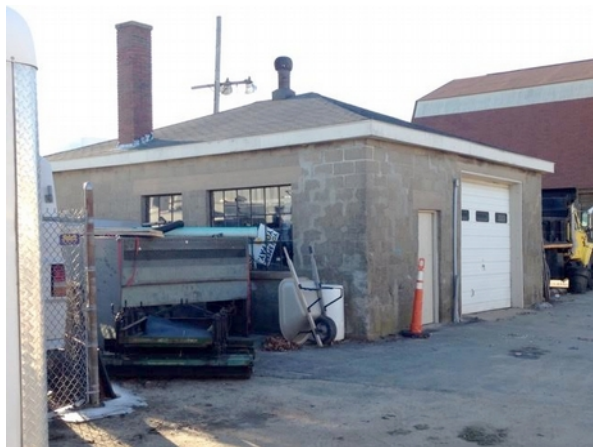
Photo 6. Blacksmith Shop, east and north (façade) elevations.

Completing the trio of mid 20th century buildings in this complex is the Blacksmith Shop (1944; Photo 6). This small concrete-block building rises one story to a low hip roof. A narrow pedestrian door and larger vehicular bay occupy its asymmetrical north (façade) elevation, while fenestration on the asymmetrical side and back elevations consists of rectangular windows with steel sash of varied sizes. A brick chimney rises above the east slope of the roof.

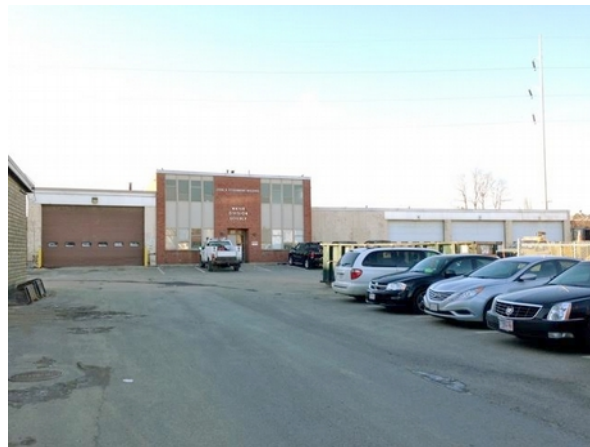
Photo 7. Water Service Building, east (façade) elevation.

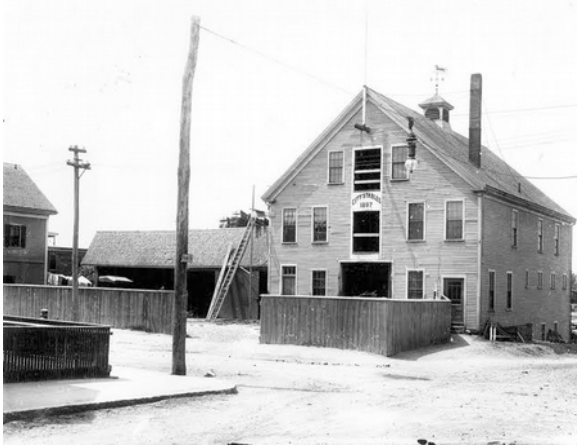
Photo 8. City Stables at Park and Roundy streets. East (façade) and north elevations, ca. 1900.

In the 1897 atlas, the present site was undeveloped and bisected by a narrow inlet that ran from southwest to northeast through the property. The open land at the southwest corner of Park and Roundy streets was owned by E. P. Rich. Shortly thereafter, the City Stables were constructed at this corner. The Stables appear in an historic photograph as a large, barn-like, wood frame structure of 2 ½ stories, its gable end facing Park Street; an attached one-story wagon shed extends to the south (Photo 8). A sign on the front wall names the building and the year 1897.

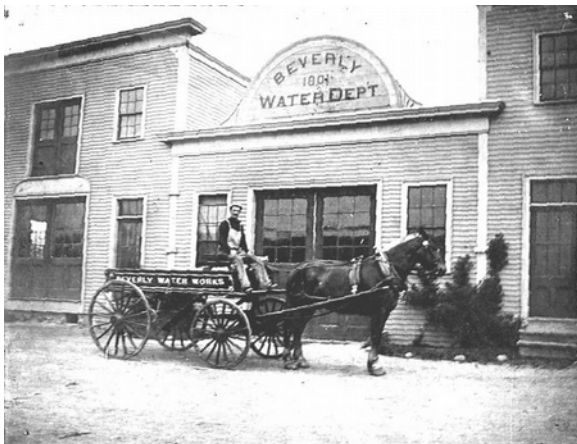
Photo 9. Water Dept. Building at west end of Roundy St. South (façade) elevation, ca. 1900.

The city water department likely occupied this property by 1907, when a one- and two-story wood frame building owned by the City is shown facing the northwest end of Roundy Street (not extant). Specifically identified as the water department by 1919, the L-shaped structure survived at least until 1963. (Photos 9 and 10)

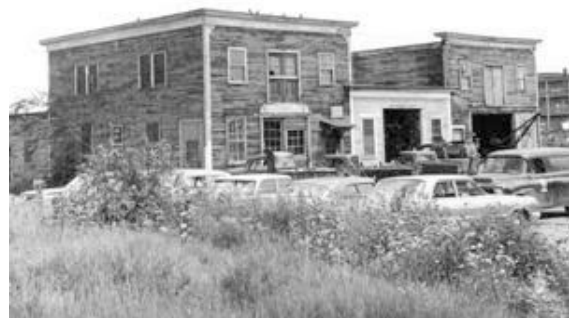
Photo 10. Water Dept. Building at west end of Roundy St. West and south (façade) elevations, 1963.
